NASA TECHNICAL NOTE

NASA TN D-6599

ANALYSIS OF SURVEYOR III TELEVISION CABLE AFTER RESIDENCE ON THE MOON

by Frederick C. Gross and John J. Park Goddard Space Flight Center Greenbelt, Md. 20771

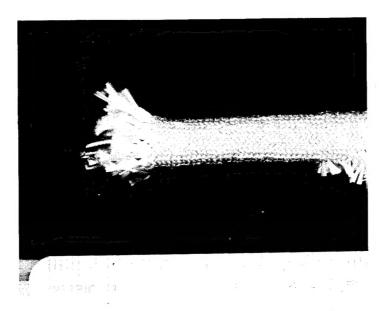
The Surveyor cable, as was mentioned previously, consisted of a glass fabric sleeve over 19 insulated wires (Figure 1). The fabric itself appeared to be a dirty gray, darker than the TAT sample. Some small particles, presumably lunar dust, were noted on the fabric (Figure 2); these particles were neither large nor very numerous. In addition, it was noted that the TAT sample also had loose pieces of metal or dirt in its fabric sleeve. However, the Surveyor sample had more particles and was darker.

Figure 1—Surveyor cable, glass fabric covering over nineteen insulated wires. (1.5X)

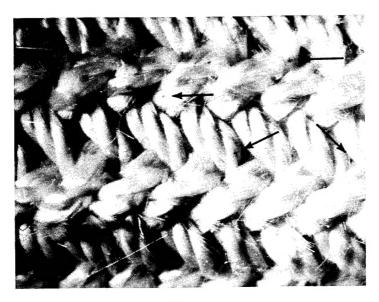
Figure 2—Enlarged view of woven glass fabric; black particles are believed to be lunar dust. (20X)

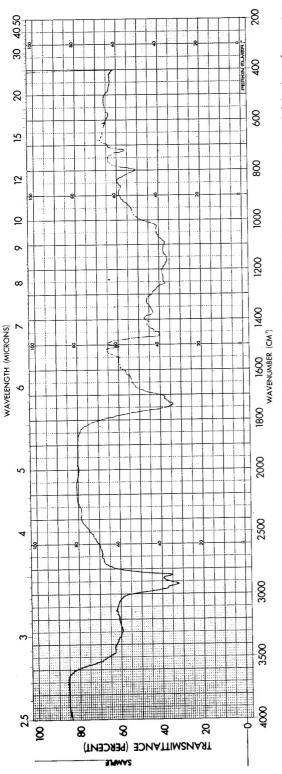
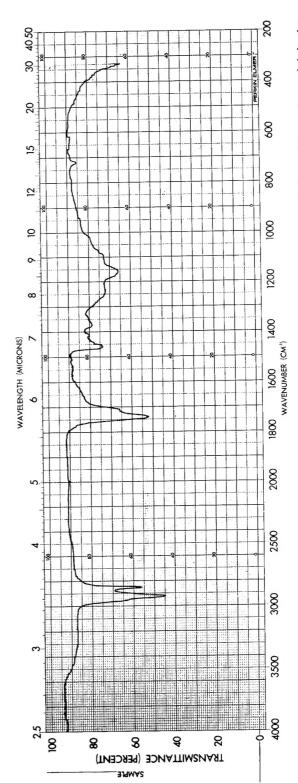
Samples of fabric were extracted with boiling chloroform. The chloroform was evaporated, and the weights of the extracts were determined. The comparison of these results was positive: The TAT sample had a 0.32-percent residue, and the Surveyor sample had a 0.21-percent residue. The residues were dissolved again, and their infrared spectra were obtained. The spectrum of the TAT sample [Figure 3(a)] showed mostly aliphatic esters and other carbonyl-containing compounds such as fatty acids. The spectrum of the Surveyor sample [Figure 3(b)] was a more clearly defined pattern of aliphatic esters, which indicated that some volatilization of the lower-boiling constituents might have occurred in the space vacuum.

Figure 3(a)—Reproduction of spectrum of chloroform extract from TAT glass fabric. [The SI equivalent of the micron (μ) is the micrometer (μm) ; 1 μ = 1 μm .]

Figure 3(b)—Reproduction of spectrum of chloroform extract from Surveyor glass fabric. [The SI equivalent of the micron (μ) is the micrometer (μ m); 1 μ = 1 μ m.]

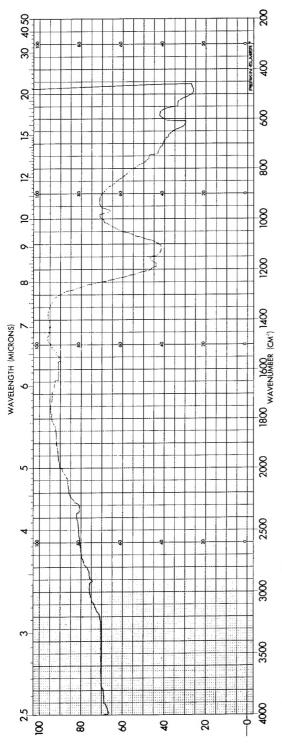
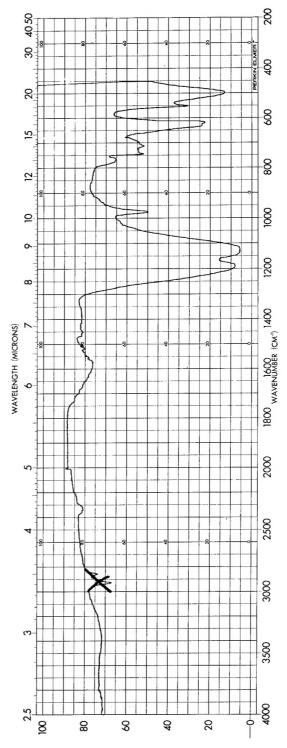
Dissolution of the outer polyimide layer by a 15-percent hot potassium-hydroxide solution was carried out. The underlying Teflon layer of the Surveyor sample showed some small areas of slight discoloration. The ATR-IR patterns yielded some slight differences in the region of 800 to $500~\rm cm^{-1}$, though it would be difficult to assign positive significance to these because of the normal variations of the test [Figures 4(a) and 4(b)]. The bands in the region of 2900 cm⁻¹ in Figure 4(b) are considered to be a residual contaminant on the infrared reflectance crystal.

Figure 4(a)—Reproduction of ATR-IR chart of TAT Teflon insulation. [The SI equivalent of the micron (μ) is the micrometer (μm); $1 \mu = 1 \mu m.$

Figure 4(b)—Reproduction of ATR-IR chart of Surveyor Teflon insulation. [The SI equivalent of the micron (μ) is the micrometer (μm);

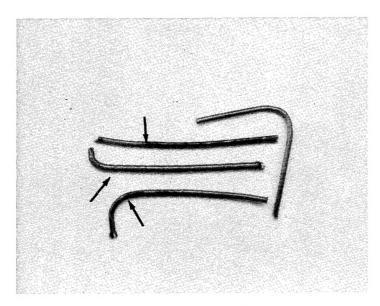
Certain portions of at least two Surveyor wires showed black areas (Figure 6). It was determined that these areas were under the insulation rather than on the surface. These areas were examined in an electron microprobe analyzer. These results showed primarily silver and copper, but also sulfur and iron; the sulfur was associated with the silver rather than with the iron. The X-ray diffraction pattern identified the black areas as silver sulfide, Ag₂S. There were also occasional areas on the wires that were determined to be high in copper and sulfur, possibly copper sulfate, CuSO₄. It must be assumed that the sulfide corrosion was on the wires before the trip to the moon, though it should be pointed out that no such areas were observed on any of the TAT wires.

Figure 6—Surveyor wires showing corrosion on three separate wires; fourth wire with large bend is from TAT.
